Great East Japan Earthquake and research and development for network resilience and recovery

5 February 2013

Noriyuki Araki

NTT, Japan

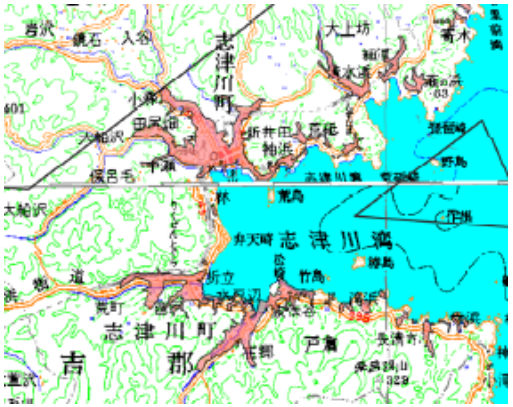
Tsunami damage in Minamisanriku-cho, Miyagi prefecture

(a) NTT manhole exposed
by destruction of riverbank protection

(b) Equipment damaged by falling bridge

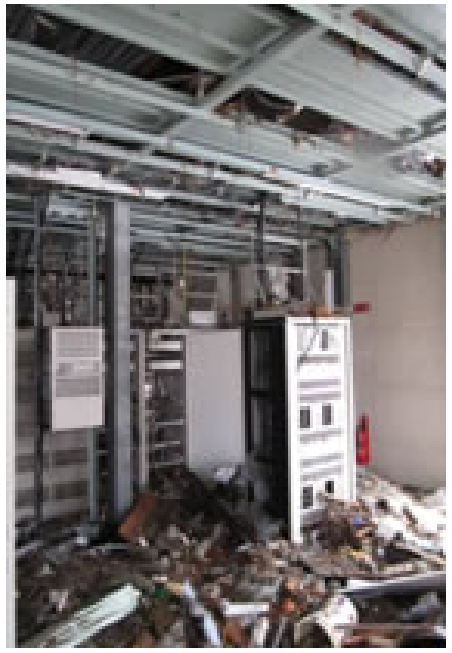
Yamada Building (Yamada Town, Iwate)

Damage to NTT buildings
